**Flood Control Project Maintenance
Levee Inspections**

Maintenance Issue Types Only, Levee Inspection Report By Mile - Spring 2015

Reclamation District No. 0563 Tyler Island

Waterway	Bank	Unit Miles	Inspection Start/End	Inspector
Unit No. 01 Georgiana Slough (Tyler Island)	Left	12.11	04/07/2015 04/07/2015	Richard Willoughby

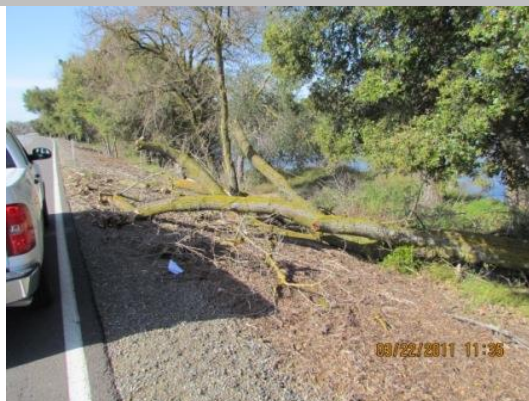
Photo 1 of 1 : SP_2015_RD0563_210_32_20150309_00034.jpg

LM Start	0.17	Rating **	M	Issue No.	32
LM End	0.17	Issue Type +	Ma	Location *	WS
Category	Earthen Levee			GPS Latitude/Longitude	
				Start	End
Item	Encroachments			38.233315 °	38.233315 °
				-121.519360 °	-121.519360 °
DWR ID	DWR_RD0563_01_s _ 2012_32				
Action/Comments					
Tree or limb					
Inspector Comments: Tree fallen across waterward slope.

Looking south (downstream) at fallen tree limb on waterside slope.

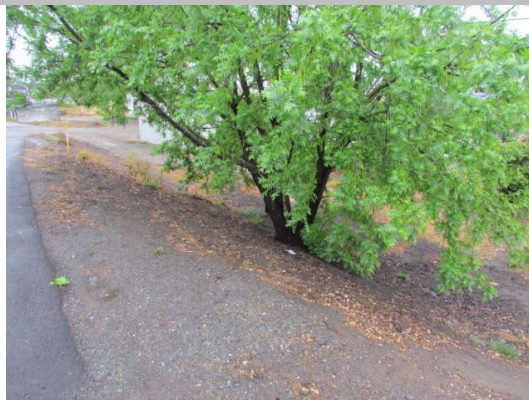
Photo 1 of 1 : SP_2015_RD0563_210_18_20150409_00965.jpg

Looking northeast at untrimmed tree on landward slope.

LM Start	0.20	Rating **	M	Issue No.	18
LM End	0.20	Issue Type +	Ma	Location *	LS
Category	Earthen Levee			GPS Latitude/Longitude	
				Start	End
Item	Trim / Thin Trees			38.232967 °	38.232967 °
				-121.519727 °	-121.519727 °
DWR ID	DWR_RD0563_01_f_2014_18				
Action/Comments					
Trim trees to at least five feet above ground level.

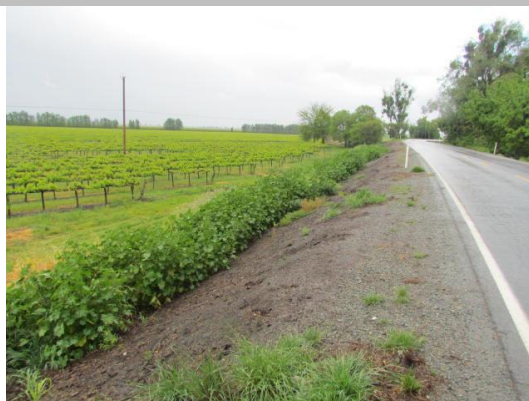
Photo 1 of 1 : SP_2015_RD0563_210_754_20150409_00968.jpg

Looking southeast at dense vegetation at landward toe.

LM Start	0.72	Rating **	M	Issue No.	754
LM End	0.79	Issue Type +	Ma	Location *	LS
Category	Earthen Levee			GPS Latitude/Longitude	
				Start	End
Item	Vegetation			38.227287 °	38.226376 °
				-121.525832 °	-121.525908 °
DWR ID	DWR_RD0563_01_s_2015_754				
Action/Comments					
Remove the wild growth other than native grasses from the levee slopes.

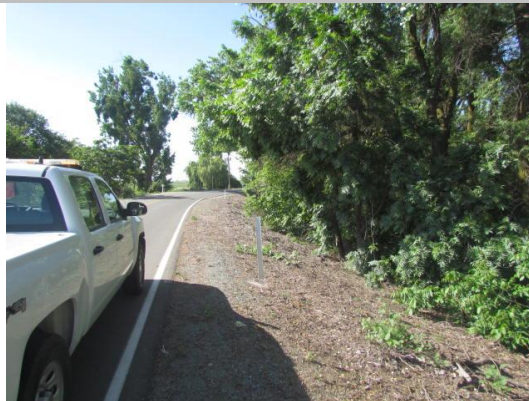
Photo 1 of 2 : SP_2015_RD0563_210_3_20150309_00001.jpg

Looking south at trimmed trees on waterward slope. (Spring 2013)

LM Start	0.79	Rating **	A/W	Issue No.	3
LM End	0.79	Issue Type +	Ma	Location *	WS
Category	Earthen Levee			GPS Latitude/Longitude	
				Start	End
Item	Trim / Thin Trees			38.226370 °	38.226370 °
				-121.525912 °	-121.525912 °
DWR ID	DWR_RD0563_01_s _ 2012_3				
Action/Comments					
Trim trees to at least five feet above ground level.

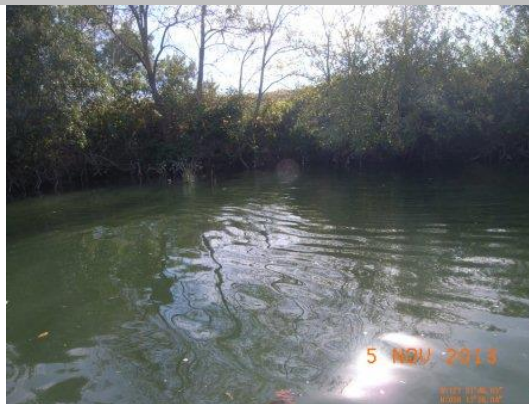
Photo 1 of 1 : SP_2015_RD0563_210_55_20150309_00053.jpg

LM Start	1.02	Rating **	M	Issue No.	55
LM End	1.11	Issue Type +	Ma	Location *	WS
Category	Supplemental			GPS Latitude/Longitude	
				Start	End
Item	USACE Erosion Survey			38.226522 °	38.227157 °
				-121.529094 °	-121.530432 °
DWR ID	DWR_RD0563_01_f_2014_55				
Action/Comments					
Inspector Comments: 2011 - Short sections of eroding bank at the waterline and holes in toe of levee. 2012 - Site extended upstream. 2013: Erosion pockets filled with an insufficient amounts of revetment. [2013 Site ID: GEO_11-0_L]

USACE 2013 Photo #1

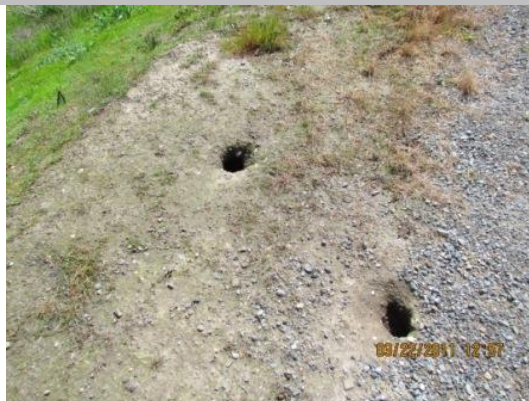
Photo 1 of 1 : SP_2015_RD0563_210_33_20150309_00035.jpg

Looking southeast at squirrel holes on landside shoulder.

LM Start	2.19	Rating **	M	Issue No.	33
LM End	2.19	Issue Type +	Ma	Location *	LS
Category	Earthen Levee			GPS Latitude/Longitude	
				Start	End
Item	Animal Control			38.218463 °	38.218463 °
				-121.542650 °	-121.542650 °
DWR ID	DWR_RD0563_01_s_2012_33				
Action/Comments					
Exterminate rodents and backfill and compact or grout burrows. Inspector Comments: Rodent holes on landside shoulder.

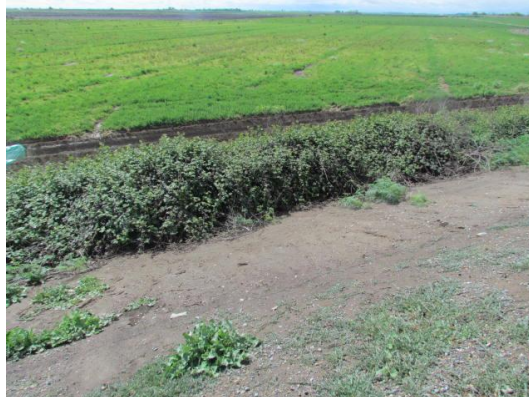
Photo 1 of 1 : SP_2015_RD0563_210_67_20150409_00973.jpg

Looking east at dense vegetation at landward toe.

LM Start	2.94	Rating **	M	Issue No.	67
LM End	2.94	Issue Type +	Ma	Location *	LS
Category	Earthen Levee			GPS Latitude/Longitude	
				Start	End
Item	Vegetation			38.210402 °	38.210402 °
				-121.535268 °	-121.535268 °
DWR ID	DWR_RD0563_01_s_2012_67				
Action/Comments					
Remove the wild growth other than native grasses from the levee slopes.					
Inspector Comments: Vines (Berry or wildroses) on landside toe.

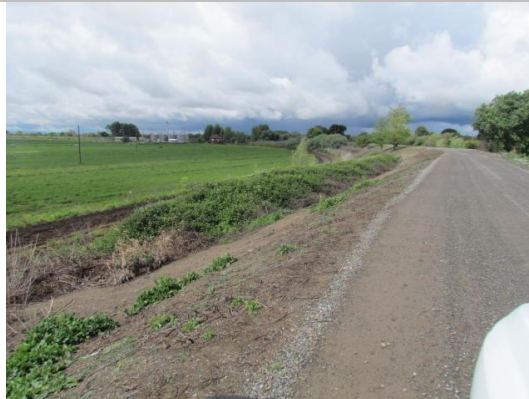
Photo 1 of 3 : SP_2015_RD0563_210_74_20150409_00974.jpg

Looking southeast at dense berryvines at landward toe. (Spring 2015)

LM Start	3.02	Rating **	U	Issue No.	74
LM End	3.21	Issue Type +	Ma	Location *	LS
Category	Earthen Levee			GPS Latitude/Longitude	
				Start	End
Item	Vegetation			38.210212 °	38.209165 °
				-121.536728 °	-121.539920 °
DWR ID	DWR_RD0563_01_s_2012_74				
Action/Comments					
Remove the wild growth other than native grasses from the levee slopes.					
Inspector Comments: Dead berryvines at landside toe blocking view of toe.

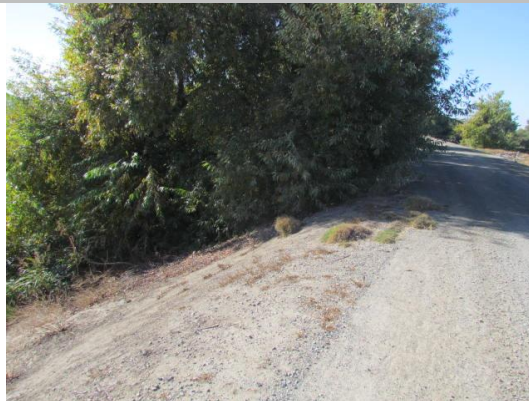
Photo 1 of 2 : SP_2015_RD0563_210_68_20150309_00071.jpg

Looking south at dense trees on landward slope.

LM Start	3.21	Rating **	U	Issue No.	68
LM End	3.21	Issue Type +	Ma	Location *	LS
Category	Earthen Levee			GPS Latitude/Longitude	
				Start	End
Item	Trim / Thin Trees			38.209217 °	38.209217 °
				-121.539823 °	-121.539823 °
DWR ID	DWR_RD0563_01_s _ 2012_68				
Action/Comments					
Thin trees to allow visibility of the ground and room to flood fight.

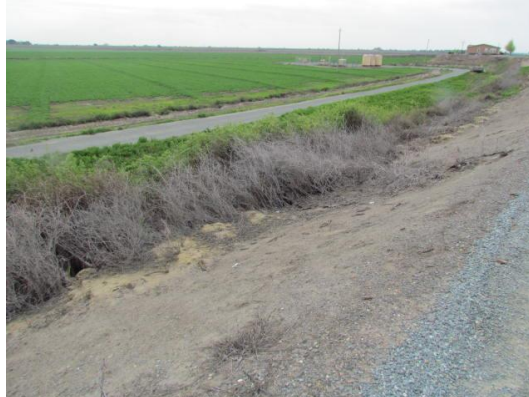
Photo 1 of 2 : SP_2015_RD0563_210_84_20150309_00093.jpg

Looking southeast at dead berryvines on landward toe.

LM Start	3.50	Rating **	A/W	Issue No.	84
LM End	3.50	Issue Type +	Ma	Location *	LS
Category	Earthen Levee			GPS Latitude/Longitude	
				Start	End
Item	Vegetation			38.205130 °	38.205130 °
				-121.540397 °	-121.540397 °
DWR ID	DWR_RD0563_01_f_2012_84				
Action/Comments					
Remove the wild growth other than native grasses from the levee slopes.					
Inspector Comments: Vegetation at landward toe.

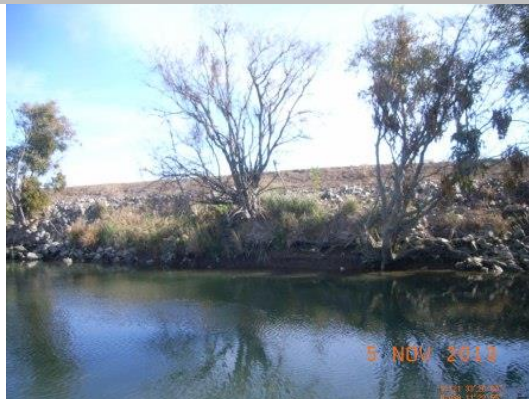
Photo 1 of 1 : SP_2015_RD0563_210_51_20150309_00050.jpg

LM Start	3.91	Rating **	M	Issue No.	51
LM End	4.01	Issue Type +	Ma	Location *	WS
Category	Supplemental			GPS Latitude/Longitude	
				Start	End
Item	USACE Erosion Survey			38.200733 °	38.199925 °
				-121.542571 °	-121.544249 °
DWR ID	DWR_RD0563_01_f_2014_51				
Action/Comments					
Inspector Comments: 1997 - Narrow eroding berm upstream of existing rock. 2001 - Staked, low fascine walls at bankline. 2011 - Minor new erosion. Site extended downstream. 2012 - Rock repair failing in one erosion pocket. 2013: No observed changes. [2013 Site ID: GEO_8-3_L]

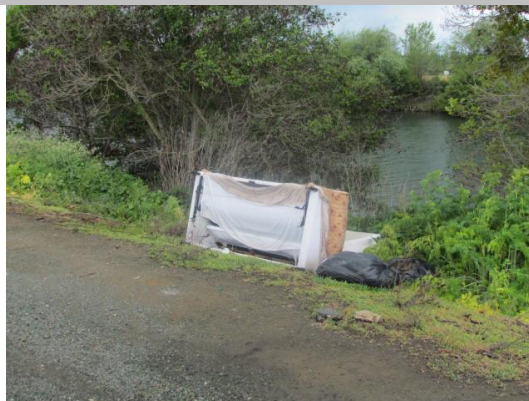
Photo 1 of 1 : SP_2015_RD0563_210_765_20150409_00976.jpg

LM Start	4.16	Rating **	M	Issue No.	765
LM End	4.16	Issue Type +	Ma	Location *	WS
Category	Earthen Levee			GPS Latitude/Longitude	
				Start	End
Item	Encroachments			38.198087 °	38.198087 °
				-121.545560 °	-121.545560 °
DWR ID	DWR_RD0563_01_s _ 2015_765				
Action/Comments					
Garbage					
Inspector Comments: Sofa and other gabage on waterward slope.

Looking west at garbage on waterward slope. (Spring 2015)

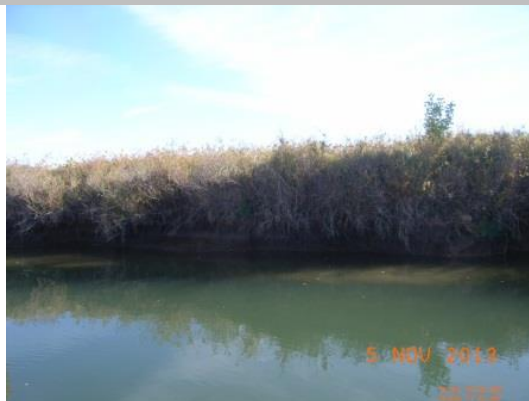
Photo 1 of 1 : SP_2015_RD0563_210_49_20150309_00047.jpg

LM Start	4.98	Rating **	M	Issue No.	49
LM End	5.04	Issue Type +	Ma	Location *	WS
Category	Supplemental			GPS Latitude/Longitude	
				Start	End
Item	USACE Erosion Survey			38.190073 °	38.189524 °
				-121.556307 °	-121.557227 °
DWR ID	DWR_RD0563_01_f _ 2014_49				
Action/Comments					
Inspector Comments: 2009 - Small scallops of erosion into the levee toe behind brush boxes. 2011 - Minor new erosion. 2012 - Site extended upstream to account for addition erosion pockets. 2013: No observed changes. [2013 Site ID: GEO_7-2_L]

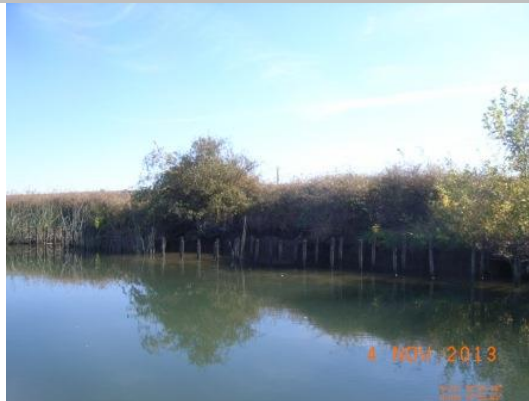
Photo 1 of 1 : SP_2015_RD0563_210_46_20150309_00045.jpg

Inspector Comments: 1997 - Deep pockets of erosion and narrow berm. Reach is characterized by lots of pockets into the existing berm and/or levee slope. 1999 - Some pockets filled with rock riprap. 2000 - Exposed fabric. 2001 - Staked, low fascine walls at bankline. 2002 - New spot of rock at upstream end. Some new brush boxes. 2005 - Some stone sliding off the underlying geotextile fabric. Some new brush bundles in the brush boxes; some with missing bundles. Some boxes too low relative to high tide. 2009 - Minimal new erosion, site length extended. 2010 - New erosion on downstream end, site extended downstream. 2011 - Sites 6.1. 6.4 and 6.6 were combined. New erosion pockets, site extended to include the erosion in between the old sites. 2012 - Rock has been placed in portions of the bank since last year. 2013: No observed changes. [2013 Site ID: GEO_6-3_L]

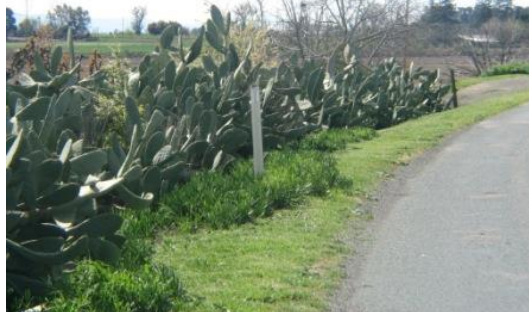
Photo 2 of 2 : SP_2015_RD0563_210_22_20150309_00026.jpg

Large cactus plant on landward slope from LM 6.04 to 6.08

LM Start	5.92	Rating **	U	Issue No.	22 (cont)
LM End	5.96	Issue Type +	Ma	Location *	LS
Category	Earthen Levee			GPS Latitude/Longitude	
				Start	End
Item	Vegetation			38.181965 °	38.181763 °
				-121.569913 °	-121.570447 °
DWR ID	DWR_RD0563_01_s _ 2012_22				
Action/Comments					
Remove the wild growth other than native grasses from the levee slopes.					
Inspector Comments: Large cactus on landward slope.

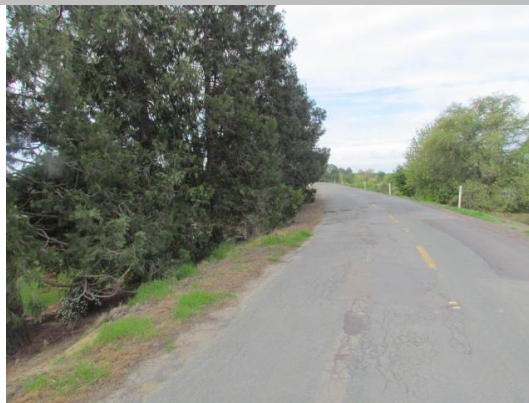
Photo 1 of 1 : SP_2015_RD0563_210_23_20150309_00027.jpg

Looking south at trees on landward shoulder.

LM Start	6.26	Rating **	A/W	Issue No.	23
LM End	6.28	Issue Type +	Ma	Location *	LS
Category	Earthen Levee			GPS Latitude/Longitude	
				Start	End
Item	Trim / Thin Trees			38.181273 °	38.181165 °
				-121.575873 °	-121.576217 °
DWR ID	DWR_RD0563_01_s_2012_23				
Action/Comments					
Trim trees to at least five feet above ground level.

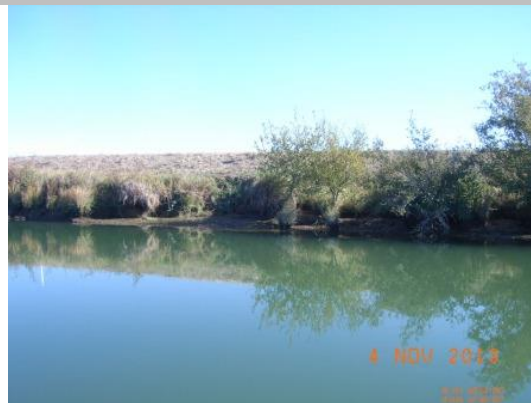
Photo 1 of 1 : SP_2015_RD0563_210_44_20150309_00043.jpg

LM Start	6.64	Rating **	M	Issue No.	44
LM End	7.28	Issue Type +	Ma	Location *	WS
Category	Supplemental			GPS Latitude/Longitude	
				Start	End
Item	USACE Erosion Survey			38.176861 °	38.167959 °
				-121.579747 °	-121.581616 °
DWR ID	DWR_RD0563_01_f_2014_44				
Action/Comments					
Inspector Comments: 1997 - Pocket erosion into the toe of the levee. 2000 - Scallops in banks with small colored flags, biotech rolls present. 2001 - Staked, low fascine walls at bankline. 2003 - Still have visibly bad spots, especially at the upstream end. 2005 - Some new brush bundles in the brush boxes; some with missing bundles. Some boxes too low relative to high tide. 2010 - Site extended upstream. 2011 - Minor new erosion. 2013: No observed changes. [2013 Site ID: GEO_5-3_L]

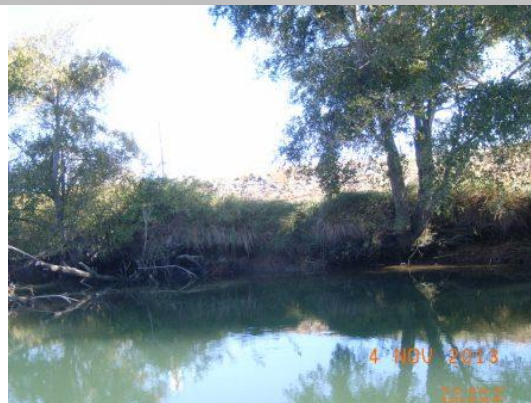
Photo 1 of 1 : SP_2015_RD0563_210_43_20150309_00042.jpg

LM Start	7.53	Rating **	U	Issue No.	43
LM End	7.80	Issue Type +	Ma	Location *	WS
Category	Supplemental			GPS Latitude/Longitude	
				Start	End
Item	USACE Erosion Survey			38.164462 °	38.160888 °
				-121.583092 °	-121.584807 °
DWR ID	DWR_RD0563_01_f_2014_43				
Action/Comments					
Inspector Comments: 1997 - Pocket erosion at upstream end and into the levee toe under the Alder trees. 2003 - New brush boxes with wattles on bank. 2004 - No brush boxes. 2005 - Site extended from the downstream side of the bridge. Whole bank is vertical. 2010 - Some minor new erosion. 2011 - Site upgraded to CRITICAL. New erosion pockets throughout the site. Sites 4.5, and 4.6 were combined. 2013: No observed changes. [2013 Site ID: GEO_4-5_L]

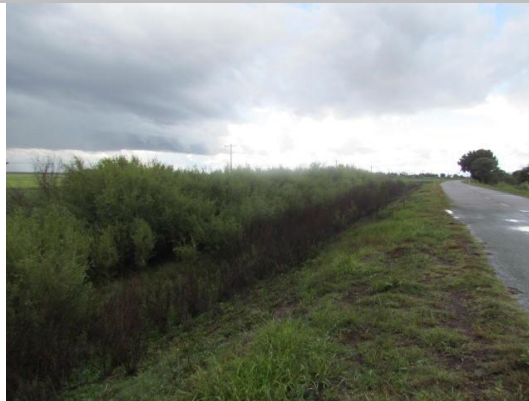
Photo 1 of 5 : SP_2015_RD0563_210_90_20150409_00980.jpg

LM Start	7.80	Rating **	M	Issue No.	90
LM End	7.82	Issue Type +	Ma	Location *	LS
Category	Earthen Levee			GPS Latitude/Longitude	
				Start	End
Item	Vegetation			38.160800 °	38.160487 °
				-121.584598 °	-121.584717 °
DWR ID	DWR_RD0563_01_s_2012_90				
Action/Comments					
Remove the wild growth other than native grasses from the levee slopes.					
Inspector Comments: Berryvines and willows on landside toe.

Looking southeast at dense vegetation at landward toe. (Spring 2015)

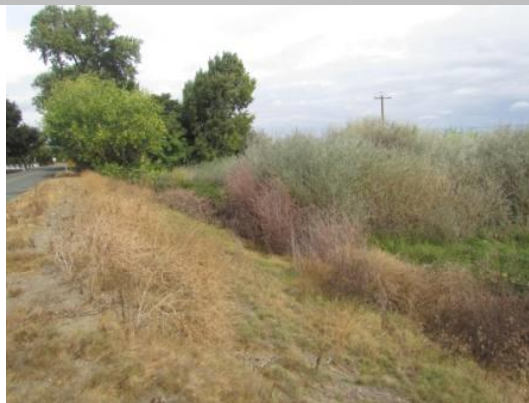
Photo 2 of 5 : SP_2015_RD0563_210_90_20150309_00103.jpg

Looking northeast at dense vegetation on landside toe.

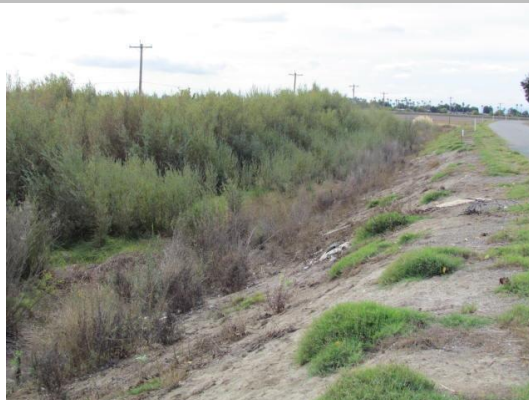
Photo 3 of 5 : SP_2015_RD0563_210_90_20150309_00104.jpg

Looking south at dense vegetation on landside toe. (2012 Fall)

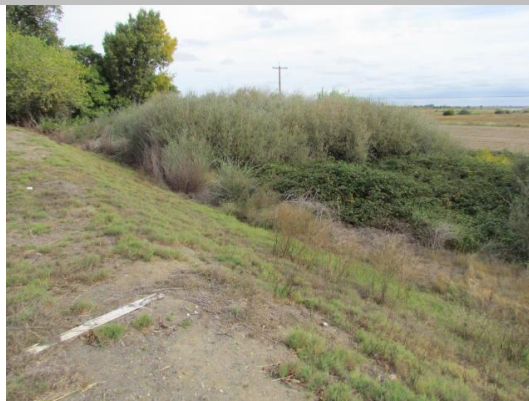
Photo 4 of 5 : SP_2015_RD0563_210_90_20150309_00105.jpg

Looking northeast at dense vegetation on landside toe. (2012 Fall Inspection)

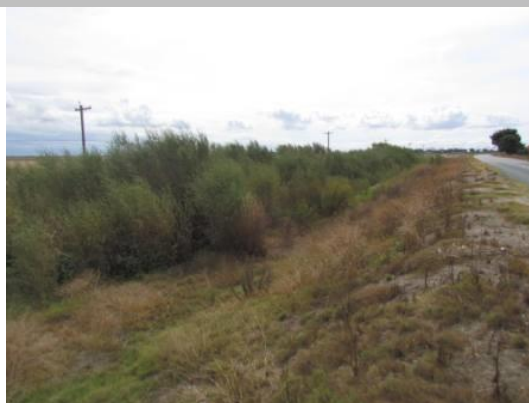
Photo 5 of 5 : SP_2015_RD0563_210_90_20150309_00106.jpg

Looking southwest at dense vegetation on landside toe.

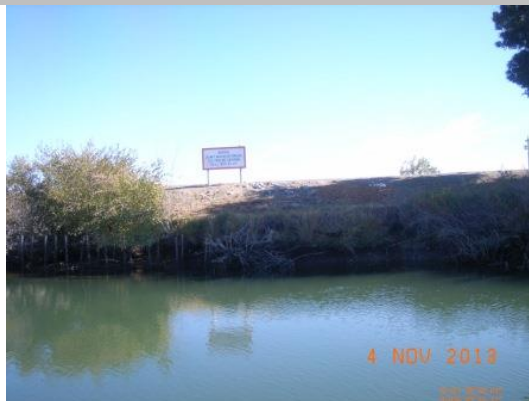
Photo 1 of 1 : SP_2015_RD0563_210_42_20150309_00041.jpg

LM Start	7.85	Rating **	M	Issue No.	42
LM End	8.05	Issue Type +	Ma	Location *	WS
Category	Supplemental			GPS Latitude/Longitude	
				Start	End
Item	USACE Erosion Survey			38.160261 °	38.157625 °
				-121.585056 °	-121.586543 °
DWR ID	DWR_RD0563_01_f_2014_42				
Action/Comments					
Inspector Comments: 1997 - Pockets of erosion into the levee toe. 1999 - Minor rock riprap and willow bundles place in a couple of spots. 2001 - Staked, low fascine walls at bankline. 2003 - Small unprotected pockets still eroding. 2004 - Numerous brush boxes, some falling apart, some with new bundles. 2005 - Some new brush boxes installed; some boxes are empty. Levee slope and banks still look bad

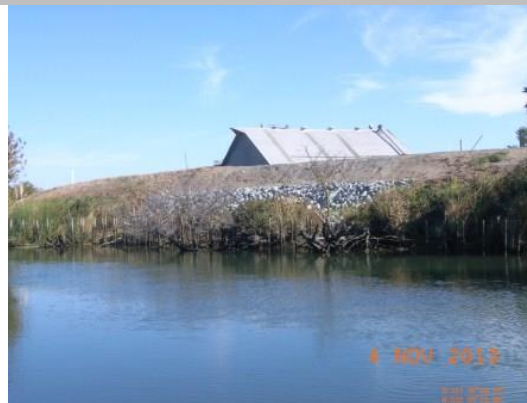
Photo 1 of 1 : SP_2015_RD0563_210_41_20150309_00040.jpg

LM Start	8.12	Rating **	M	Issue No.	41
LM End	8.59	Issue Type +	Ma	Location *	WS
Category	Supplemental			GPS Latitude/Longitude	
				Start	End
Item	USACE Erosion Survey			38.156987 °	38.152919 °
				-121.587427 °	-121.591129 °
DWR ID	DWR_RD0563_01_f_2014_41				
Action/Comments					
Inspector Comments: 1997 - Pockets of erosion into the levee at the water line. Alders are being undercut and rotating out into the channel. Damaged rock at upstream end. 2000 - New minor erosion. 2001 - Staked low fascine walls at bankline. 2002 - New "Brush Boxes" along the bank toe. 2003 - New erosion pockets in the middle of the site. 2005 - Some new bundles in the brush boxes. 2011 - Site upgraded to CRITICAL. Significant new erosion. Sites 3.6, 3.7, 3.71, and 4.0 were combined. 2012 - Rock has been placed in some of the erosion pockets since last year, however site remains critical. 2013: Site no longer critical. The worst pockets were filled with rock by the local RD. [2013 Site ID: GEO_3-8_L]

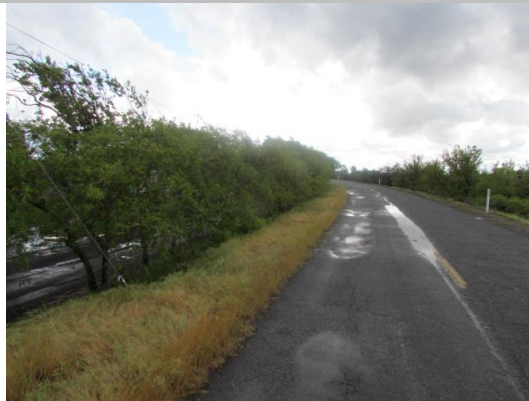
Photo 1 of 1 : SP_2015_RD0563_210_31_20150409_00982.jpg

Looking south at untrimmed trees at landward toe.

LM Start	8.38	Rating **	M	Issue No.	31
LM End	8.45	Issue Type +	Ma	Location *	LS
Category	Earthen Levee			GPS Latitude/Longitude	
				Start	End
Item	Trim / Thin Trees			38.155974 °	38.155005 °
				-121.591452 °	-121.591640 °
DWR ID	DWR_RD0563_01_s_2012_31				
Action/Comments					
Trim trees to at least five feet above ground level.

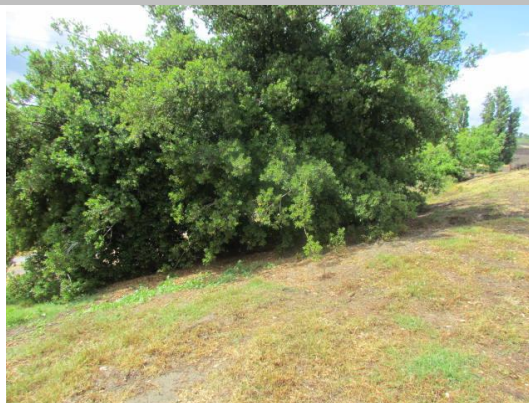
Photo 1 of 1 : SP_2015_RD0563_210_98_20150409_00983.jpg

Looking southeast at untrimmed trees on landward slope.

LM Start	9.28	Rating **	U	Issue No.	98
LM End	9.28	Issue Type +	Ma	Location *	LS
Category	Earthen Levee			GPS Latitude/Longitude	
				Start	End
Item	Trim / Thin Trees			38.145825 °	38.145825 °
				-121.588807 °	-121.588807 °
DWR ID	DWR_RD0563_01_s_2013_98				
Action/Comments					
Trim trees to at least five feet above ground level.

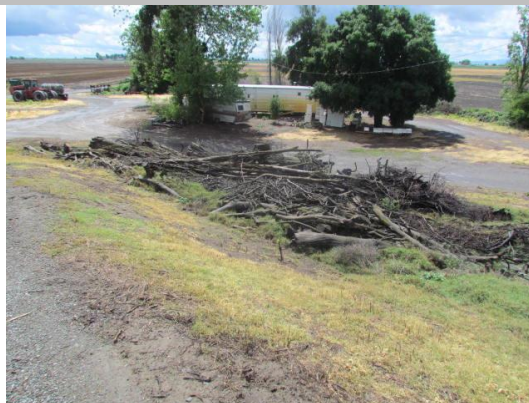
Photo 1 of 2 : SP_2015_RD0563_210_73_20150409_00984.jpg

LM Start	9.33	Rating **	U	Issue No.	73
LM End	9.33	Issue Type +	Ma	Location *	LS
Category	Earthen Levee			GPS Latitude/Longitude	
				Start	End
Item	Encroachments			38.145957 °	38.145957 °
				-121.589653 °	-121.589653 °
DWR ID	DWR_RD0563_01_s_2012_73				
Action/Comments					
Prunings					
Inspector Comments: Large pruning pile on landward toe.

Looking east at prunings at landward toe. (Spring 2015)

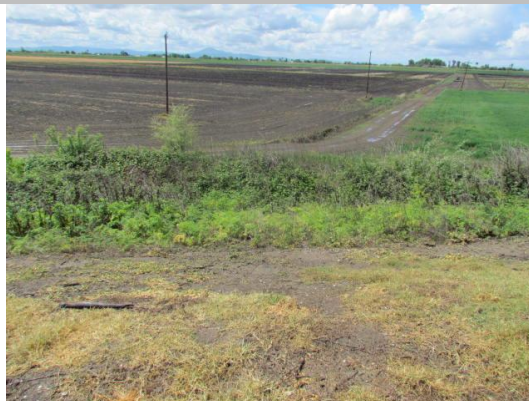
Photo 1 of 1 : SP_2015_RD0563_210_769_20150409_00985.jpg

Looking east at dense vegetation at landward toe. (Spring 2015)

LM Start	9.36	Rating **	U	Issue No.	769
LM End	9.43	Issue Type +	Ma	Location *	LS
Category	Earthen Levee			GPS Latitude/Longitude	
				Start	End
Item	Vegetation			38.146276 °	38.147034 °
				-121.590189 °	-121.590907 °
DWR ID	DWR_RD0563_01_s _ 2015_769				
Action/Comments					
Remove the wild growth other than native grasses from the levee slopes.

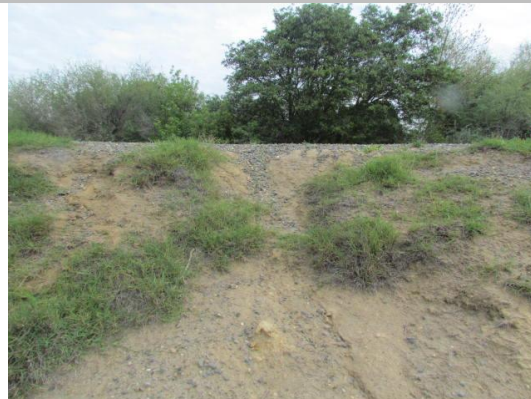
Photo 1 of 2 : SP_2015_RD0563_210_99_20150309_00114.jpg

Looking west at minor erosion on landward shoulder and slope.

LM Start	9.65	Rating **	M	Issue No.	99
LM End	9.65	Issue Type +	Ma	Location *	LS
Category	Earthen Levee			GPS Latitude/Longitude	
				Start	End
Item	Erosion / Bank Caving			38.149905 °	38.149905 °
				-121.592910 °	-121.592910 °
DWR ID	DWR_RD0563_01_s_2013_99				
Action/Comments					
Note and monitor erosion site.

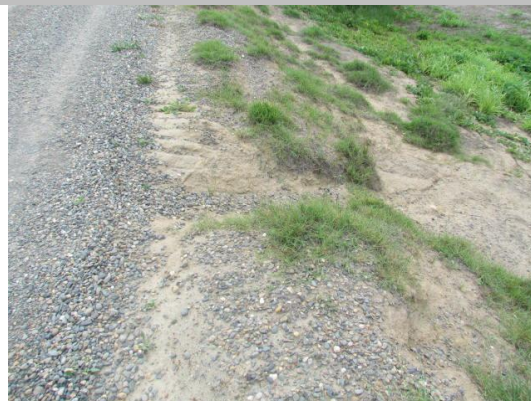
Photo 2 of 2 : SP_2015_RD0563_210_99_20150309_00115.jpg

Looking north at minor erosion on landward shoulder and slope.

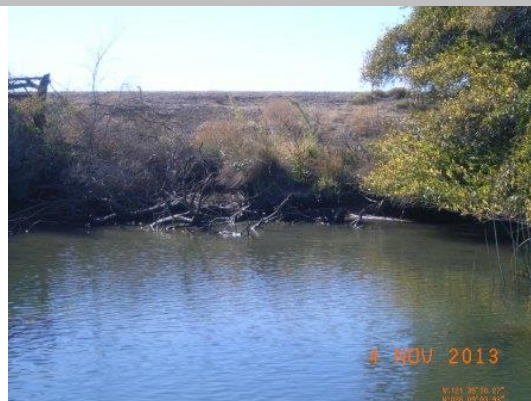
Photo 1 of 1 : SP_2015_RD0563_210_40_20150309_00039.jpg

LM Start	9.73	Rating **	M	Issue No.	40
LM End	9.90	Issue Type +	Ma	Location *	WS
Category	Supplemental			GPS Latitude/Longitude	
				Start	End
Item	USACE Erosion Survey			38.150820 °	38.150647 °
				-121.593650 °	-121.596858 °
DWR ID	DWR_RD0563_01_f_2014_40				
Action/Comments					
Inspector Comments: 1997 - Erosion pockets into the toe of the levee. 2001 - Staked low fascine walls at the bankline. 2004 - Numerous "Brush Boxes." 2005 - Some new bundles in the brush boxes. 2012 - Site extended downstream to account for new bank sloughing. 2013: Some rock added to the upstream end by the local RD. [2013 Site ID: GEO_2-5_L]

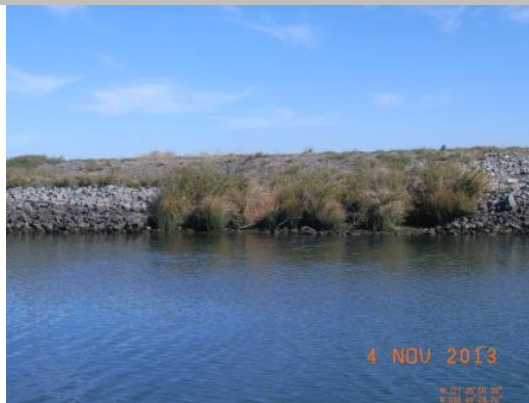
Photo 1 of 1 : SP_2015_RD0563_210_39_20150309_00038.jpg

LM Start	10.45	Rating **	M	Issue No.	39
LM End	10.74	Issue Type +	Ma	Location *	WS
Category	Supplemental			GPS Latitude/Longitude	
				Start	End
Item	USACE Erosion Survey			38.143519 °	38.139918 °
				-121.599677 °	-121.596986 °
DWR ID	DWR_RD0563_01_f_2014_39				
Action/Comments					
Inspector Comments: 1997 - Old damaged rock riprap along the toe. 1999 - Downstream end (400 ft) repaired with rock. 2002 - New rock/concrete rubble section on the downstream end. 2004 - Small pocket repairs at the downstream end. 2005 - Some new bundles in the brush boxes. 2012 - Some rock has been placed in last year. 2013: No observed changes. [2013 Site ID: GEO_1-7_L]

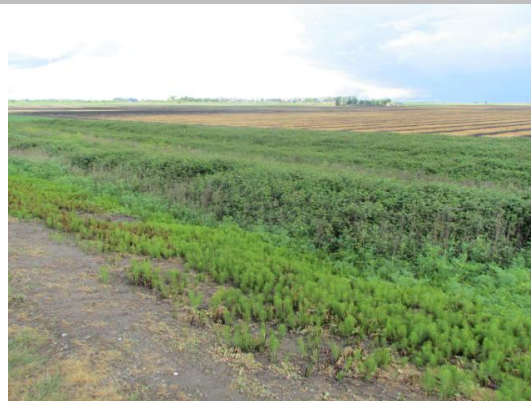
Photo 1 of 3 : SP_2015_RD0563_210_100_20150409_00987.jpg

LM Start	10.72	Rating **	U	Issue No.	100
LM End	10.81	Issue Type +	Ma	Location *	LS
Category	Earthen Levee			GPS Latitude/Longitude	
				Start	End
Item	Vegetation			38.140307 °	38.139079 °
				-121.596900 °	-121.596214 °
DWR ID	DWR_RD0563_01_s_2013_100				
Action/Comments					
Remove the wild growth other than native grasses from the levee slopes.					
Inspector Comments: Wild rose or grape vines on landward slope and toe.

Looking northeast at dense vegetation at landward toe. (Spring 2015)

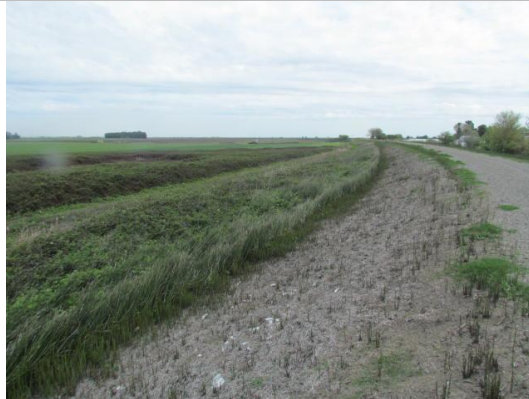
Photo 3 of 3 : SP_2015_RD0563_210_100_20150309_00116.jpg

Looking south at additional dense vegetation at landward toe.

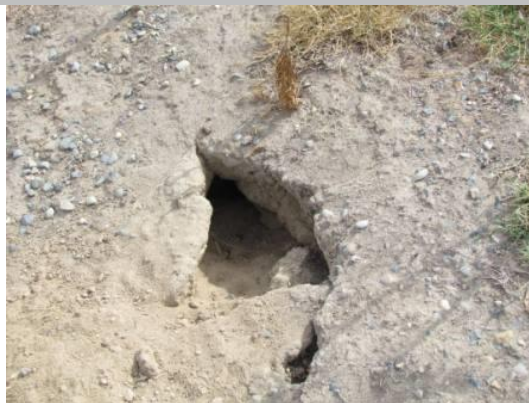
Photo 1 of 3 : SP_2015_RD0563_210_91_20150309_00107.jpg

Looking east at rodent hole on landside slope.

LM Start	11.45	Rating **	A/W	Issue No.	91
LM End	11.45	Issue Type +	Ma	Location *	LS
Category	Earthen Levee			GPS Latitude/Longitude	
				Start	End
Item	Animal Control			38.131943 °	38.131943 °
				-121.588912 °	-121.588912 °
DWR ID	DWR_RD0563_01_s_2012_91				
Action/Comments					
No rodents visible, but rodent burrows visible; need to backfill and compact or grout burrows.

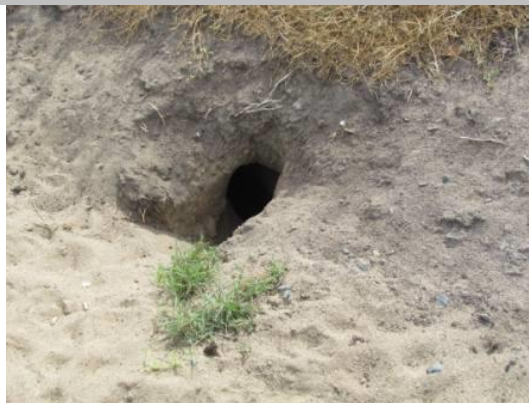
Photo 2 of 3 : SP_2015_RD0563_210_91_20150309_00108.jpg

Looking west at rodent hole on landside slope.

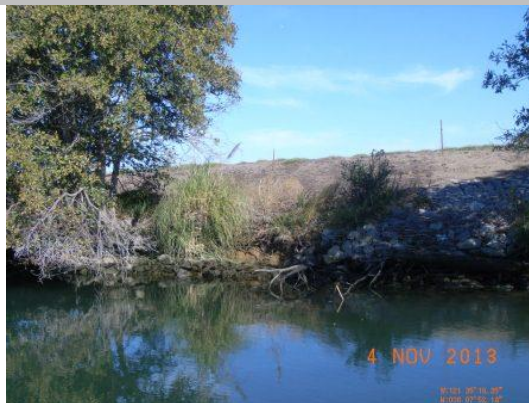
Photo 1 of 1 : SP_2015_RD0563_210_38_20150309_00037.jpg

LM Start	11.51	Rating **	M	Issue No.	38
LM End	11.70	Issue Type +	Ma	Location *	WS
Category	Supplemental			GPS Latitude/Longitude	
				Start	End
Item	USACE Erosion Survey			38.131126 °	38.129948 °
				-121.588337 °	-121.585026 °
DWR ID	DWR_RD0563_01_f_2014_38				
Action/Comments					
Inspector Comments: 1997 - Erosion pockets into the levee toe. 1999 - Some small pockets fixed with rock riprap. 2002 - New "brush boxes" along the bank toe. 2005 - Brush boxes are empty. Some pockets are filled with new stone. 2006 - Some new rock at the downstream end (~100 ft long). Several small pockets of new rock in scallops. Brush boxes in poor to fair condition. 2010 - Site looks a little worse, some
